Structural Tests of Mechanical Connections For Concrete Panels

L. E. Cattaneo and F. Y. Yokel

Final Report

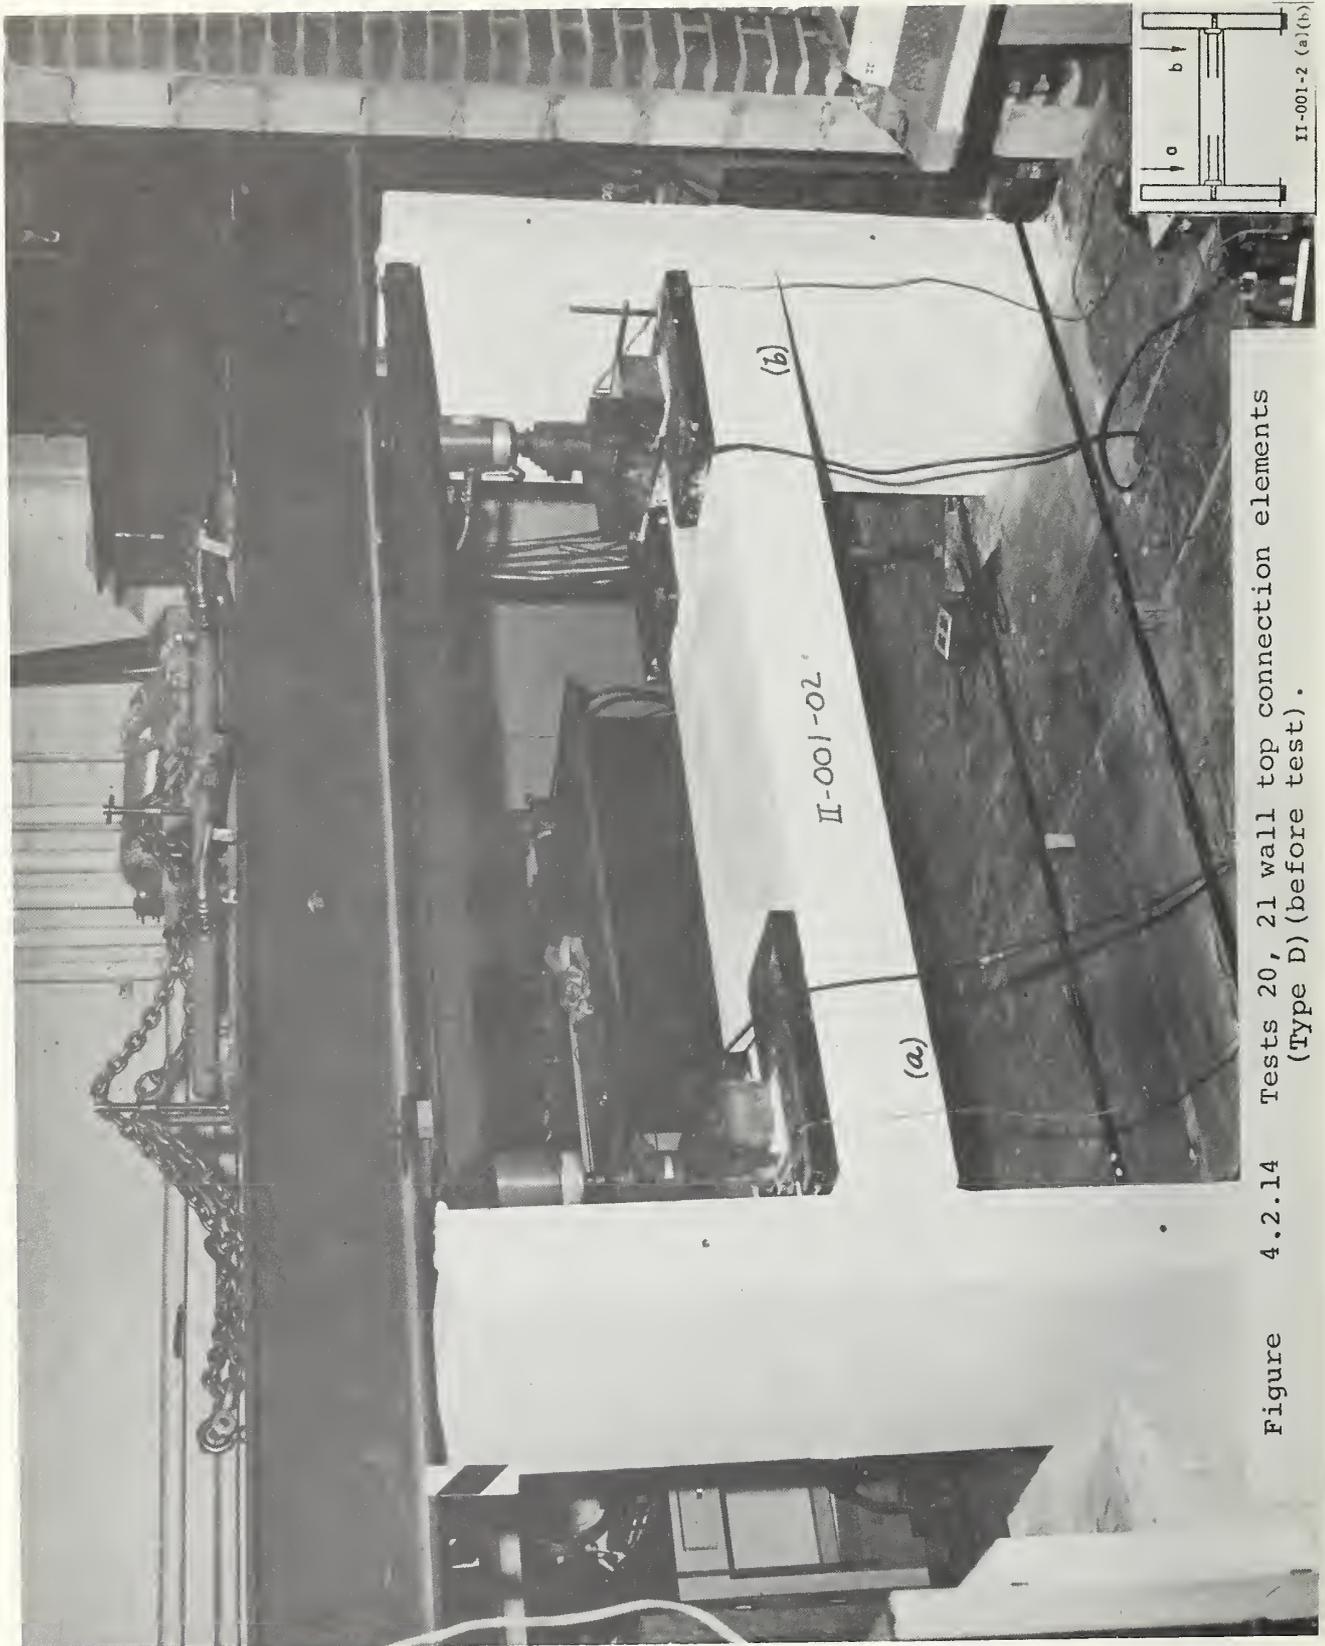
A total of six tests were conducted on three specimens. Figure 4.2.14 shows the specimen used in Tests 20 and 21. Initially, load was applied by both rams; however only one connection failed. Subsequently the other connection was loaded to failure. This procedure generated two tests for the first specimen. In subsequent specimens, tests were conducted sequentially on one end and then on the other.

In Test 20 the load reacted on large steel plates as shown in figure 4.2.14. It was determined from the failure mode (fig. 4.2.15) that this provided restraint to the concrete and thereby increased load resistance. Thus, the results of Tests 20 and 21 are high and do not represent a valid simulation. In subsequent tests the load was applied through smaller, less confining bearing plates as shown in figure 4.2.16 for Test 22.

Figure 4.2.14 Tests 20, 21 wall top connection elements (Type D) (before test).

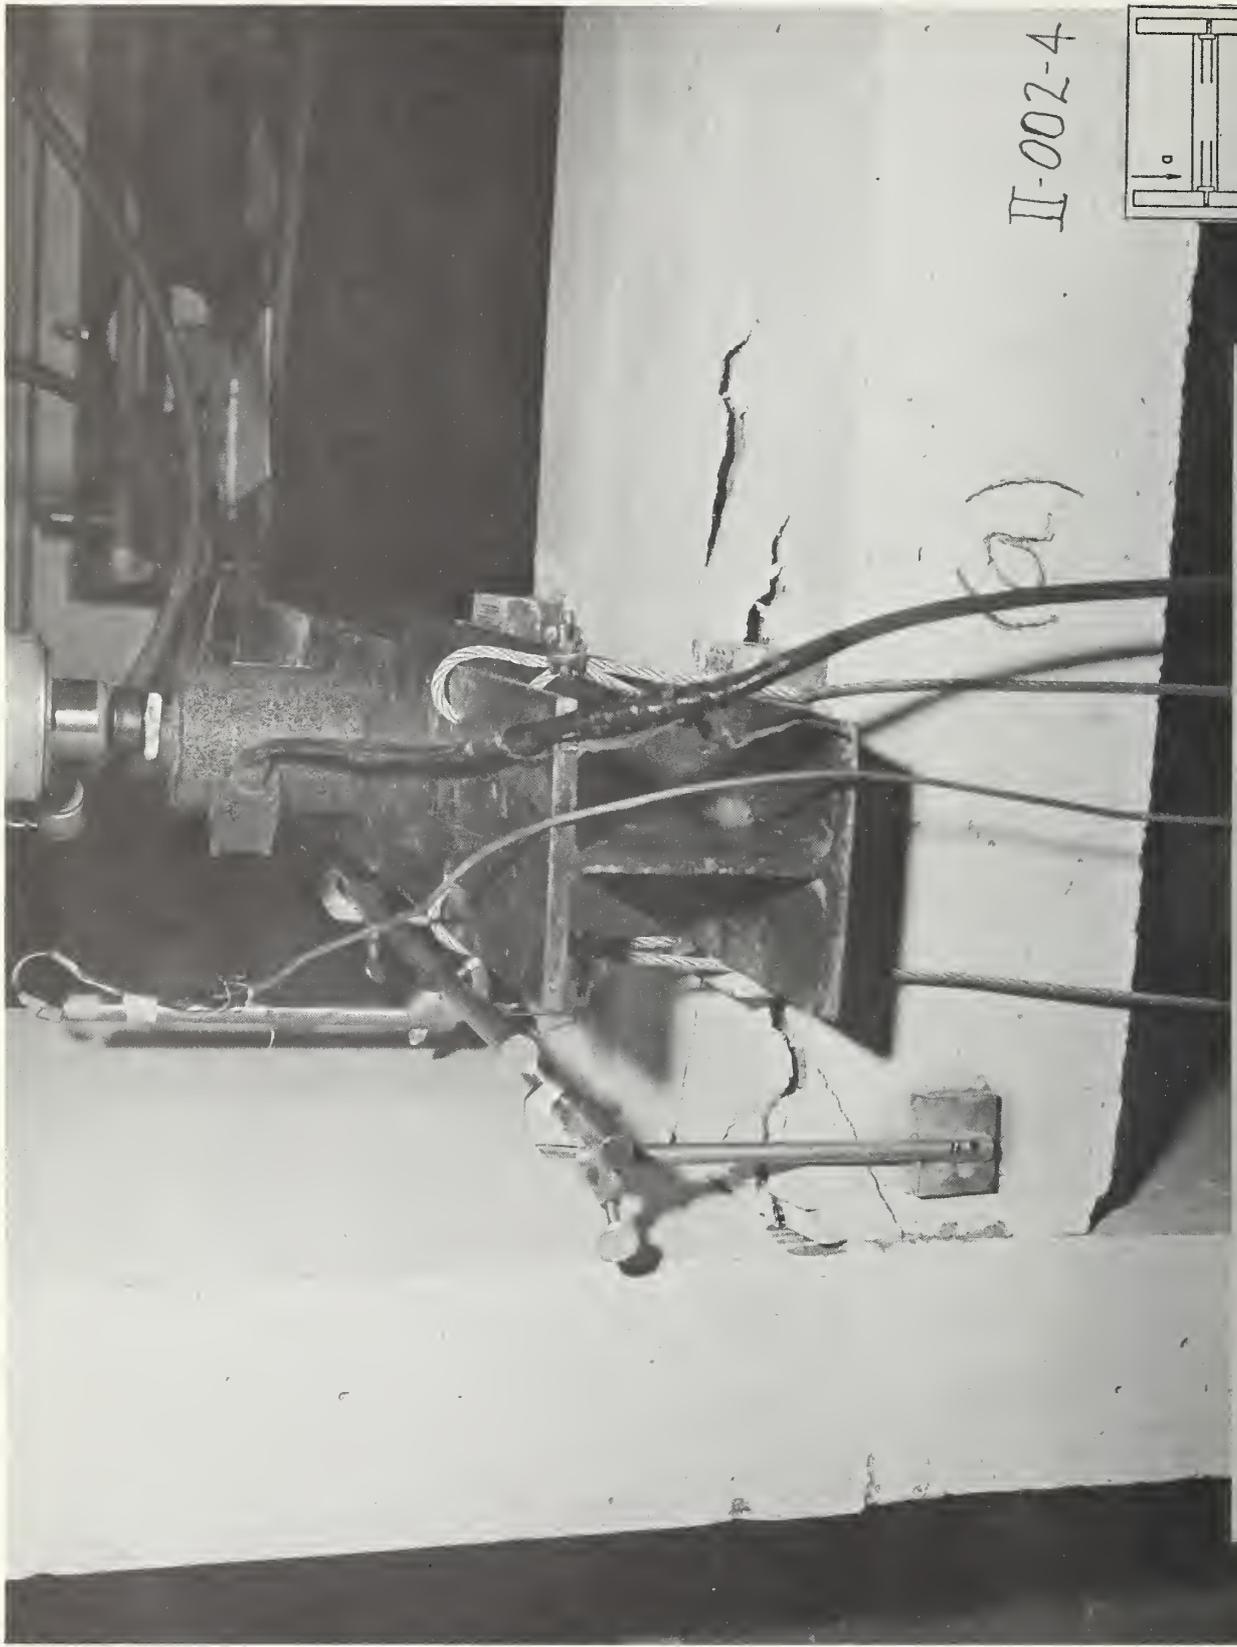
Figure 4.2.16 Test 22 wall top connection element (Type D).

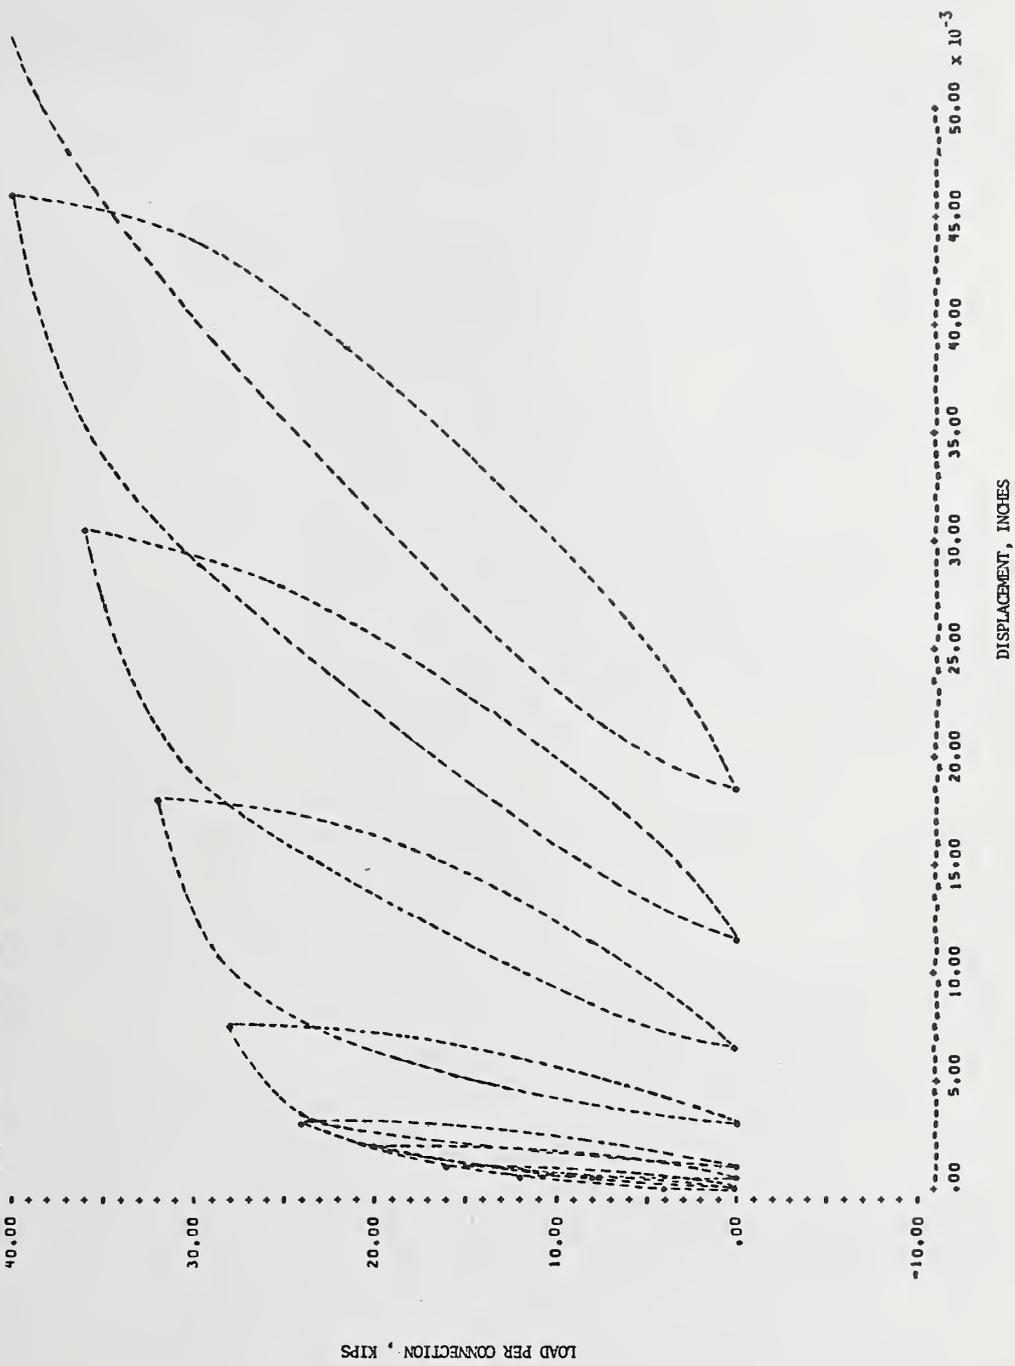
Load versus displacement is given for Test 22 in figure 4.2.17. Static load was applied in 4-kip increments and reduced to zero after each new increment. The trend in this plot is also typical of that for the other tests. Failure load in this test was determined at the point where significant distress was observed in the concrete surface of the wall. This distress coincided with a marked change in the slope of the load-displacement curve. Subsequently, large additional deformations occurred during gradual shear failure in the concrete. The ultimate load substantially exceeded the failure load. The load capacity of these connection elements provided information which is important when progressive collapse is considered.

PLOT OF INSTRUMENT 3 TOTAL LOAD IN KIPS 50K CELL
 VS. INSTRUMENT 5 LVDT 3 IN. TYPE .001 IN

Figure 4.2.17 Load-displacement graph of Test 22.

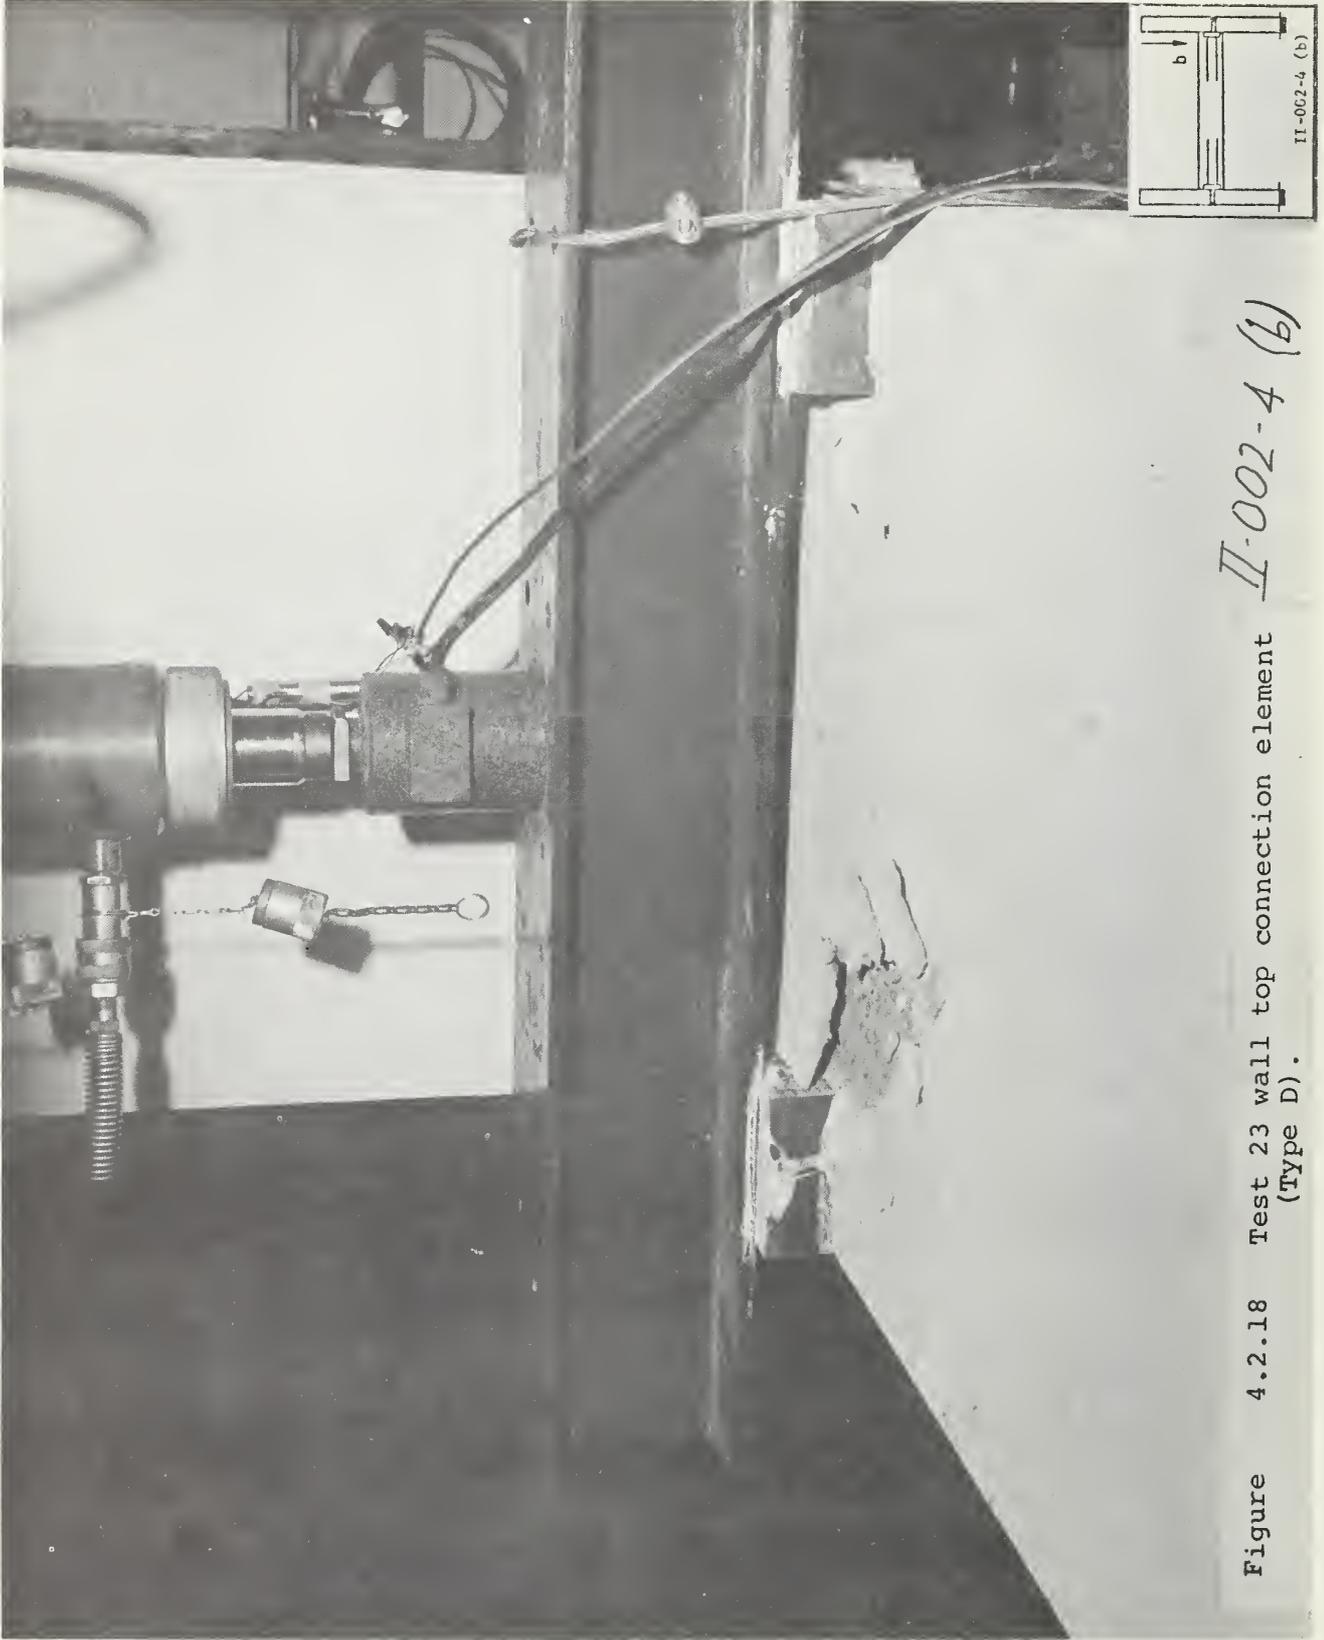
Figure 4.2.18 shows the failure mode in Test 23. Failure modes in Tests 24 and 25 are shown in Figures 4.2.19 and 4.2.20, respectively. In each case considerable spalling of concrete can be observed.

Figure 4.2.18 Test 23 wall top connection element (Type D).

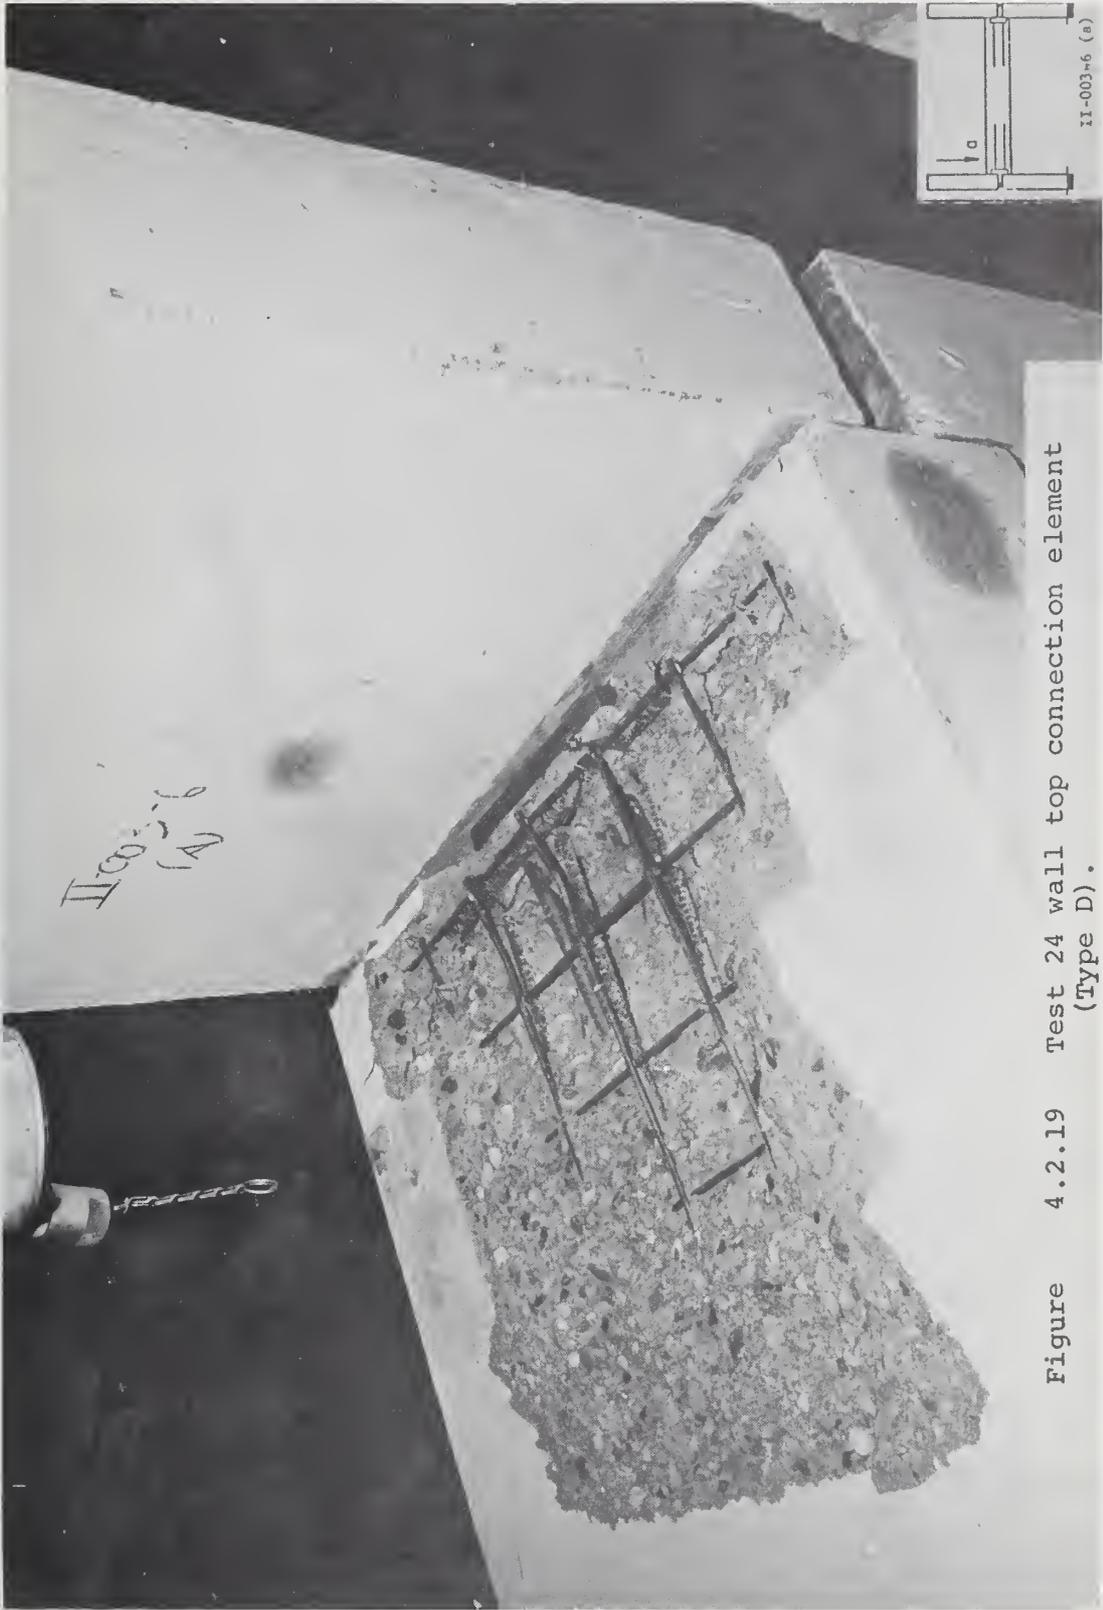
Figure 4.2.19 Test 24 wall top connection element (Type D).
